# Building Inspection Report

## Rockcliffe Mansion

1000 Bird,  
Hannibal, MO

**Inspection Date:**  
09/18/09

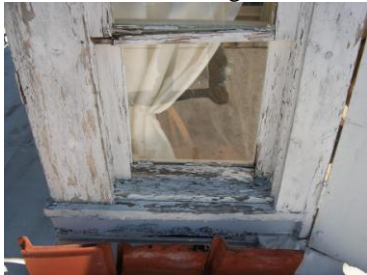
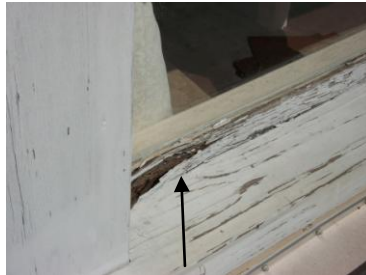
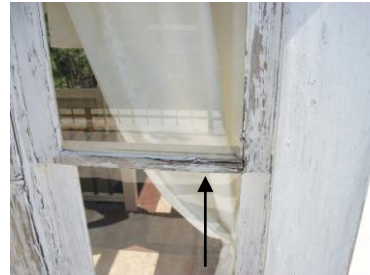
- **Major Concern, Repair:** The window frames in the observatory room are dilapidated and should be replaced. Watch for unsafe loose glass.

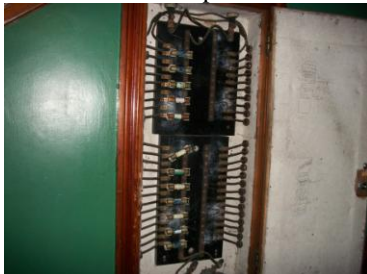
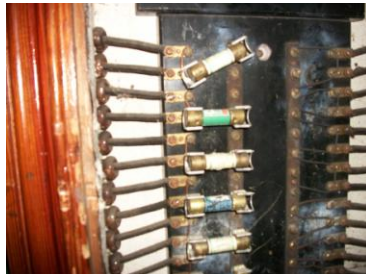
- **Major Concern:** Auxiliary panel also has a double tap on its main.
- **Major Concern:** Inspection of the electrical system revealed the need for numerous repairs. These should be high priority for safety reasons. *Unsafe electrical conditions represent a shock hazard.* A licensed electrician should be consulted to undertake the repairs recommended below.

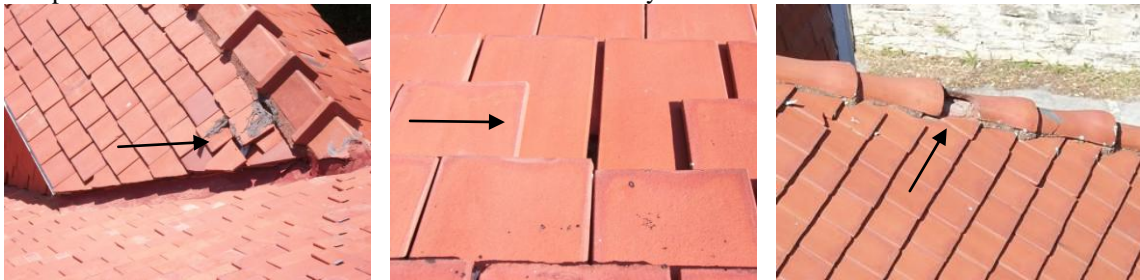
- **Repair:** Minor repairs to the roofing are needed. Damaged or missing roofing material should be repaired. All roof penetrations should be examined and sealed as necessary.

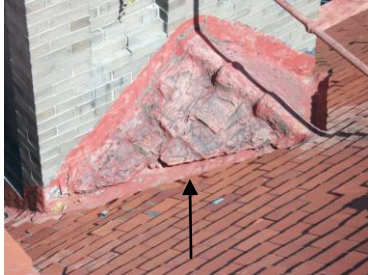
- **Repair:** The flashing is damaged around the boiler chimney and should be repaired to avoid leaks.

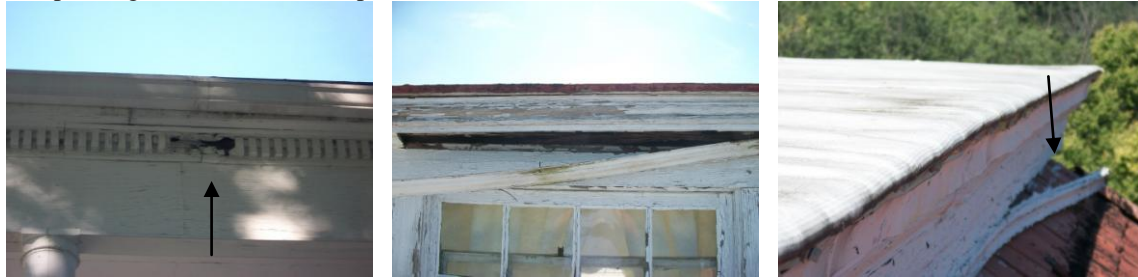
- **Repair:** Localized rot and damage was observed in the fascia (the wooden board to which the gutter is typically fastened) and trim. Improvement is not necessary at present, although this condition should be repaired when exterior painting or maintenance are planned.

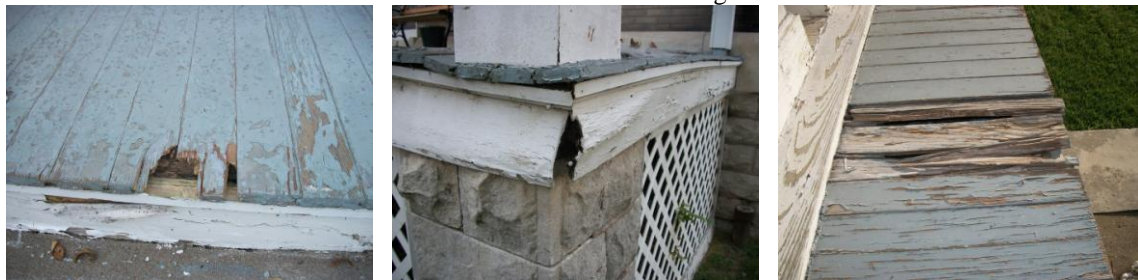
- **Repair:** All porches show evidence of rot. Replacement may eventually be desired. In the interim, localized repairs should be undertaken. There is risk of additional hidden damage.

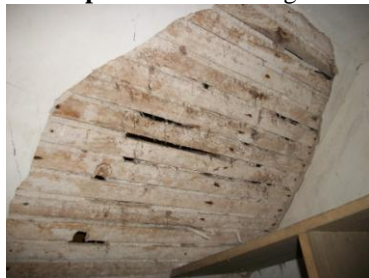
- **Repair:** Water damage was noted in the basement stairwell closet and in the servant stairwell.

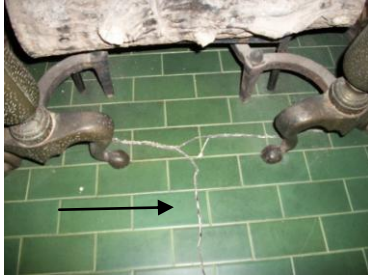
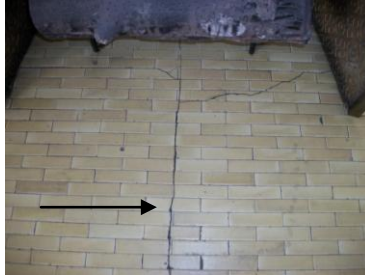
- **Repair:** Cracked hearth in Mr. C room and the girl's room.

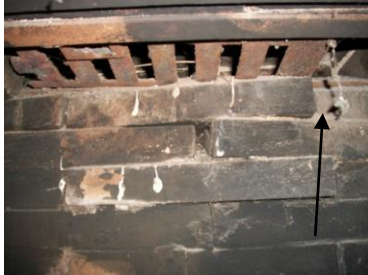
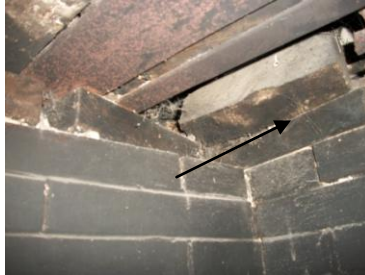
- **Repair:** Fireplace in red room has damage to some bricks.

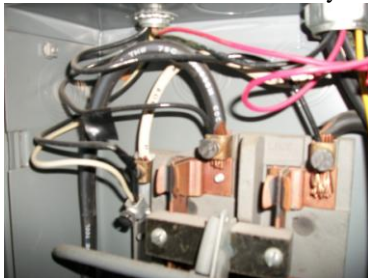
- **Repair:** Circuits within the auxiliary panel that are doubled up (referred to as "double taps") should be separated. Each circuit should be served by a separate fuse or breaker.

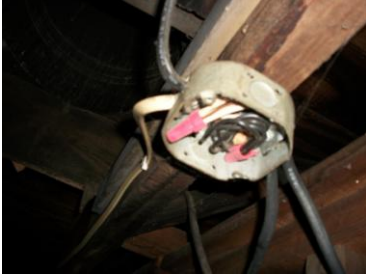
- **Repair:** All junction boxes should be fitted with cover plates, in order to protect the wire connections.

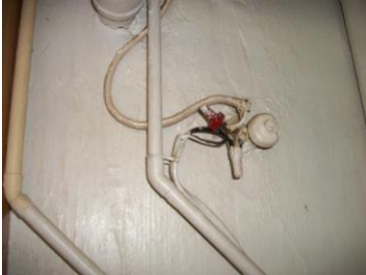
- **Repair:** All spliced wiring should be covered in a junction box.

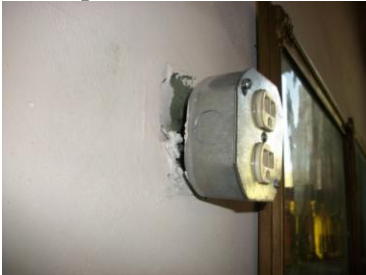
- **Repair:** An outlet box is loose in the kitchen. It should be secured.

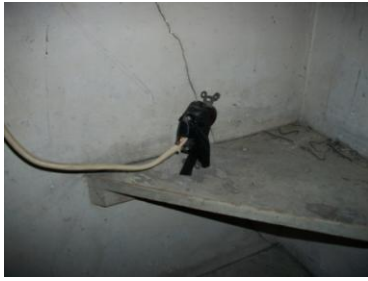
- **Repair:** The sconce light over the book case in the red room is inoperative. If the bulbs are not blown, the circuit should be repaired.
- **Repair:** The sconce light in the rose room bathroom on the right side is inoperative.
- **Repair:** The sconce in Mr. Cruikshank bedroom is inoperative.
- **Repair:** Second floor hall closet light inoperative.
- **Repair:** Outlet hanging in washer room should be secured to wall.

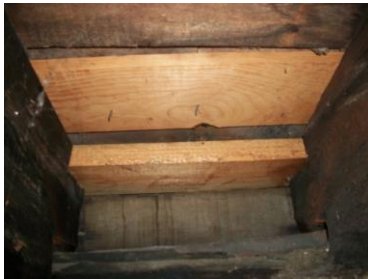
- **Monitor:** The design of the roofing system is such that several vulnerable areas exist most prominently around the dormers. There is a higher potential for leaks. Annual inspections and ongoing maintenance will be critical.
- **Monitor:** Prior repairs to the roofing are evident. This would suggest that problems have been experienced in the past. This area should be monitored.

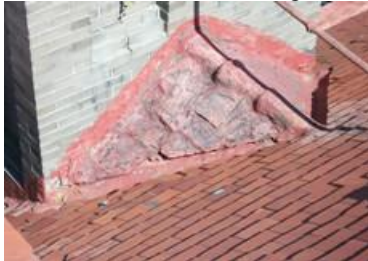
- **Monitor:** The flashing around the boiler chimney is vulnerable and should be carefully monitored for leaks.

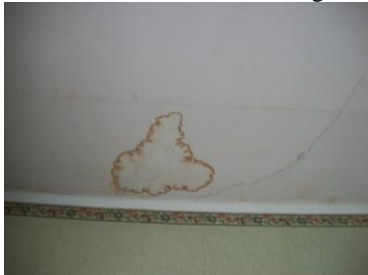
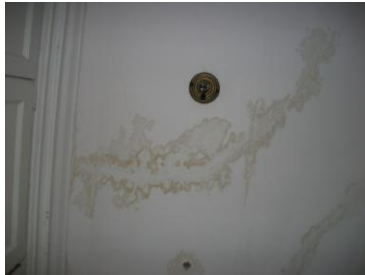
- **Monitor:** Water staining was noted in the ballroom and bathroom between Mr. C room and girl's room.

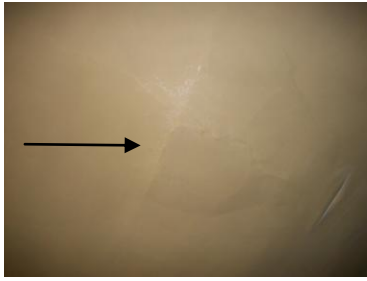
- **Monitor:** Evidence of patching was detected.
- **Monitor:** Minor cracks were noted in most rooms.
- **Monitor:** Loose or weakened finishes were detected in most rooms.
- **Monitor:** The plaster shows evidence of bulging in the music room. Repairs may be desirable.

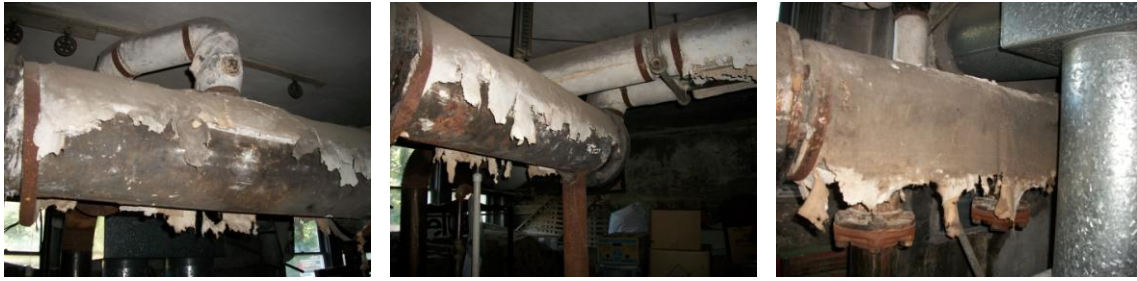
- **Monitor:** Insulation on the boiler and/or distribution piping may contain asbestos. *The Environmental Protection Agency (E.P.A.) reports that asbestos represents a health hazard if “friable” (damaged, crumbling, or in any state that allows the release of fibers).* If replacement of the boiler necessitates the removal of the asbestos containing insulation, an asbestos removal specialist should be engaged. If any sections of this insulation are indeed friable, or become friable over time, a specialist should also be engaged. Further guidance is available from the Environmental Protection Agency (E.P.A.). There may be other materials within the home that contain asbestos but are not identified by this inspection report.
